ENGINEERING EXPERIMENT STATION
CIRCULAR SERIES No. 55

CONTRIBUTIONS TO PROCEEDINGS OF THE SECOND INTERNATIONAL CONFERENCE ON SOIL MECHANICS AND FOUNDATION ENGINEERING

I. A STUDY OF RETAINING WALL FAILURES

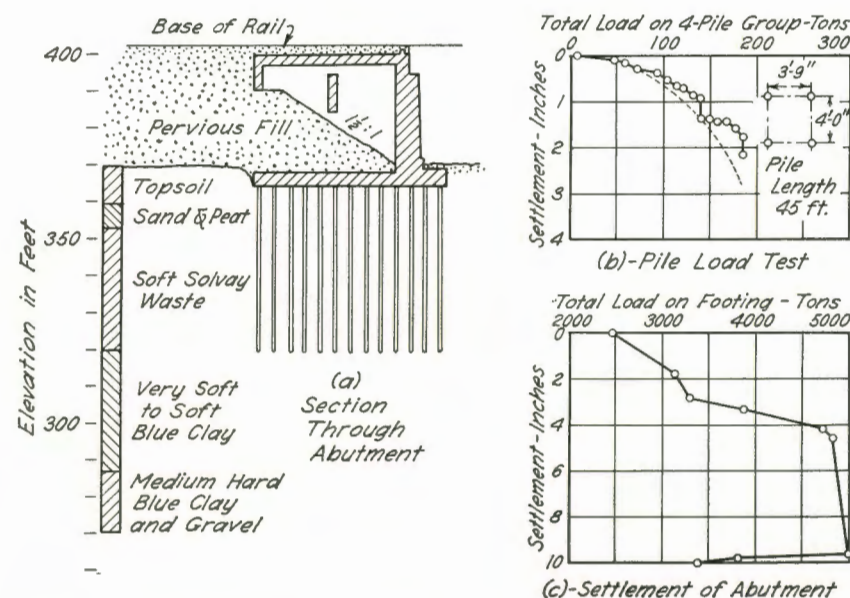
FIG. 5. UNSATISFACTORY BEHAVIOR: DATA CONCERNING ONE OF A PAIR OF OPEN ABUTMENTS CONSTRUCTED FOR A GRADE SEPARATION

The first example of unsatisfactory behavior is illustrated in Fig. 5, which shows the pertinent data concerning one of a pair of open abutments constructed for a grade separation. It was recognized that the foundation for the abutments would require pile support, and the structure was founded upon cast-in-place concrete piles having an embedment of 45 ft. One group of four of these piles was tested, with the results shown in the figure. On the basis of the test it appears that the average shearing resistance of the soil was approximately 0.17 ton per sq ft.

On the assumption that the average shearing resistance of the soft subsoil was 0.17 ton per sq ft, the total ultimate bearing capacity

of the base of the abutment should have been approximately 5300 tons. This value is in reasonable agreement with the observed load at failure. Therefore it appears obvious that the failure of the abutment was caused by overloading the subsoil and had little if any relation to the active earth pressure against the abutment.

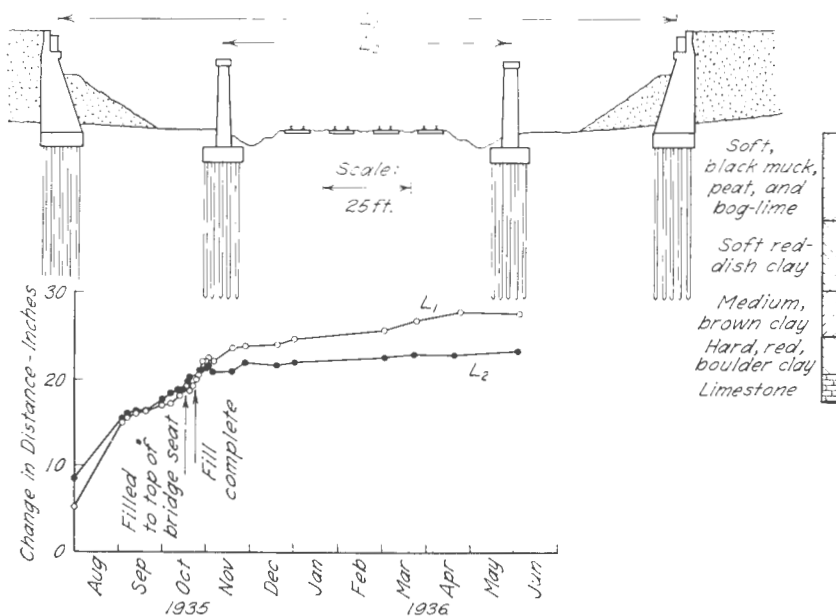
FIG. 6. UNSATISFACTORY BEHAVIOR: DATA CONCERNING A TYPICAL EXAMPLE OF PROGRESSIVE FORWARD MOVEMENT OF LARGE MAGNITUDE

Figure 6 shows the pertinent data concerning a typical example of progressive forward movement of large magnitude. The piles penetrated the soft material and rested on the medium clay at a depth of 40 ft. The two abutments and two intermediate piers for the bridge were completed, and backfilling was in progress, when movements of all four elements of the substructure were observed. Measurements

yielded the results indicated on Fig. 6. The distance L_2 between the intermediate piers decreased almost as much as the distance L_1 between abutments. This means that the movement was deep-seated and involved the lateral squeeze or flow of clay toward the center of the bridge from each end. Such a movement could hardly be caused otherwise than by overloading the clay stratum by the weight of the backfill. Under the weight of the fill the bearing capacity of the soft reddish clay and overlying material was probably approached and a slow lateral flow or creep was initiated by the excessive shearing forces. The lateral pressure against the abutment was probably not excessive, because the abutments were of the open type and the fill was allowed to extend through them.

In a large number of the other examples of progressive outward movement or tilting, conditions appeared to be similar to those indicated in Fig. 6 except that the movements were generally much smaller. This would suggest that the shearing stresses in the foundation were considerably smaller with respect to the shearing strength of the soil than in the example described. Nevertheless, it is believed that in practically all the examples the lateral forces in the subsoil of the structure were considerably greater than the computed active earth pressure. Progressive movements were observed even on several walls supported by fairly stiff clays.

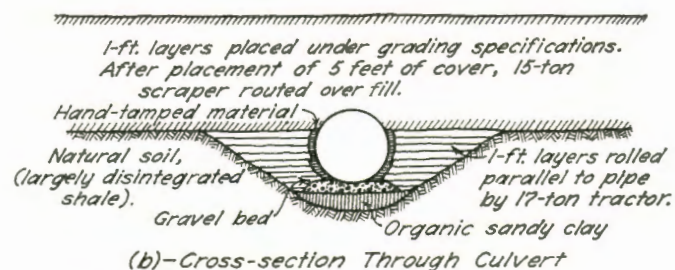
Figure 3a shows a cross-section through the fill in which Structure B was located. The depth of cover was 13 ft. A cross-section of the culvert is shown in Fig. 3b. This diagram shows the soil conditions

and the method of compaction. Except at the upstream end where the culvert rested upon shale bedrock, the structure rested on sandy clay with considerable organic matter. A bed of gravel about 18 in. thick was placed in a shallow trench excavated in this material, but as much as 4 ft of relatively compressible clay remained beneath the gravel bed. The backfill consisted of a residual silty sand derived from shale and contained numerous rather large fragments of unweathered shale. The effective size was about 0.25 mm and the uniformity coefficient 20. The liquid limit of the material passing a No. 28 mesh sieve was 44.1 per cent and the plastic limit 28.8 per cent. Hence the binder material might properly be classified as a silt of medium compressibility.

On account of the compressible material beneath the fill the base of the fill settled appreciably. The settlement of the invert of the culvert during the first three months is shown in Fig. 3a. The settlement placed the bottom of the culvert in axial tension. The only visible effects of the tension, however, were a few small cracks in the headwalls and a relative movement indicating that the upper part of the culvert was pulling out of the headwalls. At a similar site close to the location of the flexible culvert a concrete box culvert was established. It was subjected at the bottom to tension of the same nature as that experienced by the flexible culvert, and as a consequence developed a transverse crack across the invert and part way up the sides.

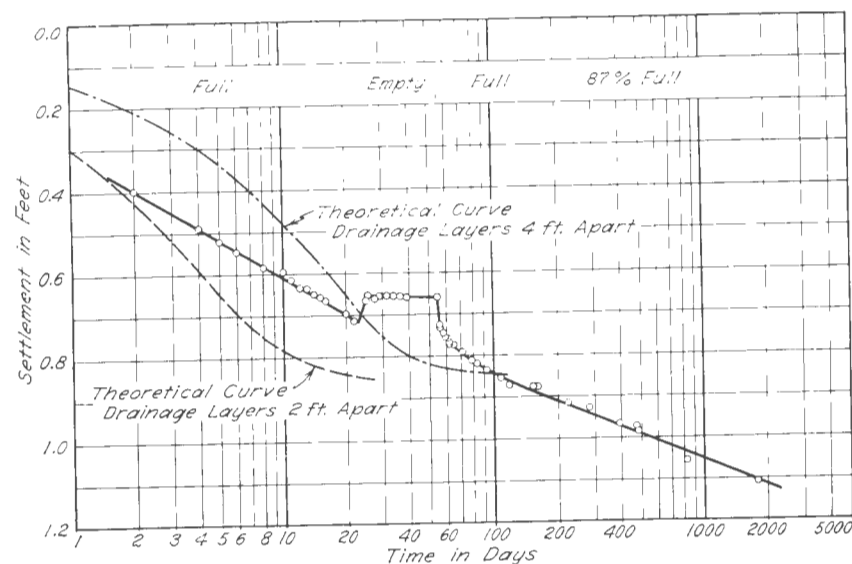
FIG. 3. RESULTS OF STUDIES OF SETTLEMENT LEVELS

At the same time that the borings were being made the results of the settlement levels were being studied. They are shown in Fig. 3, in which the average settlement is plotted as a function of the logarithm of time. It was observed that up to the time the tank was emptied the points representing the settlements fell upon a straight line. The reasons for this empirical fact were not clearly understood but it was considered improbable that the settlement should accelerate in such a manner that future points would fall below the line defined by the observations. If the trend continued at its original rate for a period of as much as 100 years, the average settlement would not exceed $1\frac{1}{2}$ ft. Since this amount could be tolerated by the pipe connections between the tank and the treating plant it was decided to refill the tank.

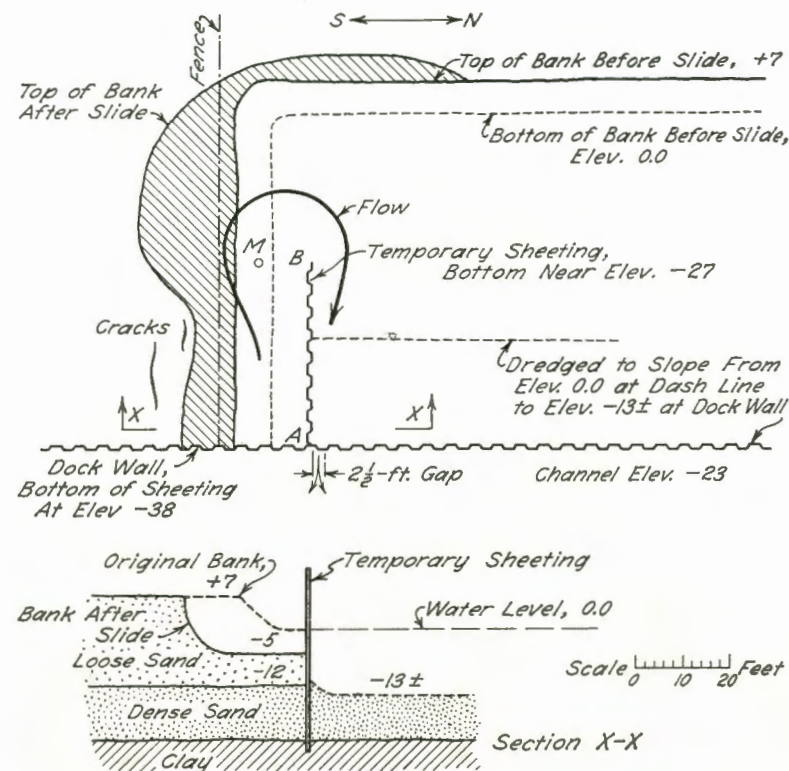
FIG. 2. PROTECTIVE MEASURES, AND OUTLINE OF BANK AFTER SLIDE

The principal manifestation of the flow was the dropping of large chunks of sand into the water at the edge of the southern bank. These pieces first cracked away from the bank and then slumped into the water and disappeared. After the slide the outline of the bank was as shown in Fig. 2. Near the east end of the bank several cracks remained. The position of the ground surface just west of the bulkhead line is

shown in Section XX. In corner A the surface of the sand had descended from El. 0 to El. -5. At point B near the end of the temporary sheeting the depth was only slightly greater. At the place where the sheeting was removed, the surface of the sand was at about El. -11. Since the total distance from A to B around the end of the temporary sheeting and back to the gap was 80 ft, the final average slope was approximately 1 on 13.

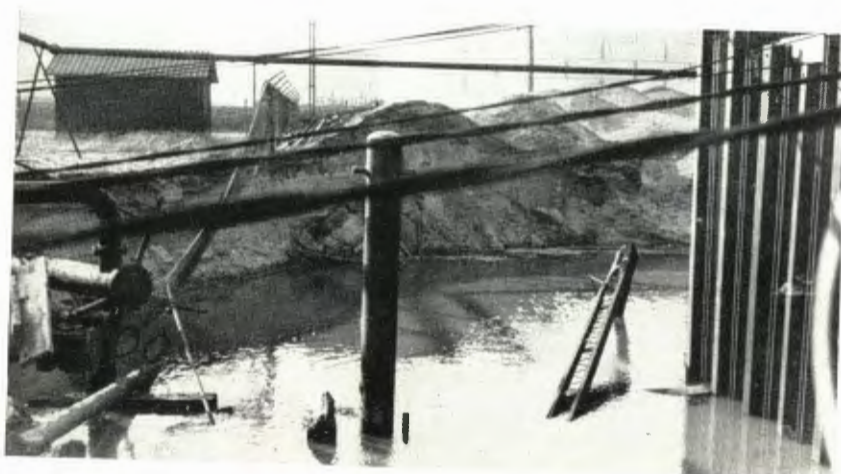
FIG. 3. CONDITIONS AFTER THE SLIDE (PHOTOGRAPH); TEMPORARY SHEET PILE WALL AND MOORING POST STILL IN POSITION

It is obvious from the drawings and the photograph that the slide was not a deep-seated phenomenon and that only the material above El. -12 was involved. Had the underlying sand layer been disturbed, the mooring post and the temporary sheeting would almost certainly have collapsed or moved. Inasmuch as the dock wall was provided with holes at water level to maintain the elevation of the water at the same level inside and outside the sheeting, no hydraulic head could have existed across the gap at the time the sheeting was removed. The relatively small disturbance caused by removing the support from a

few feet of submerged sand at the gap set into motion a flow that continued even when an extremely flat slope was attained. The movement stopped only when the gap was closed.
